Public Roads

June 1990
Vol. 54, No. 1

Model Study of the Hatchie River U.S. 51 Bridge

Effectiveness of Calcium Nitrite Admixture as a Corrosion Inhibitor

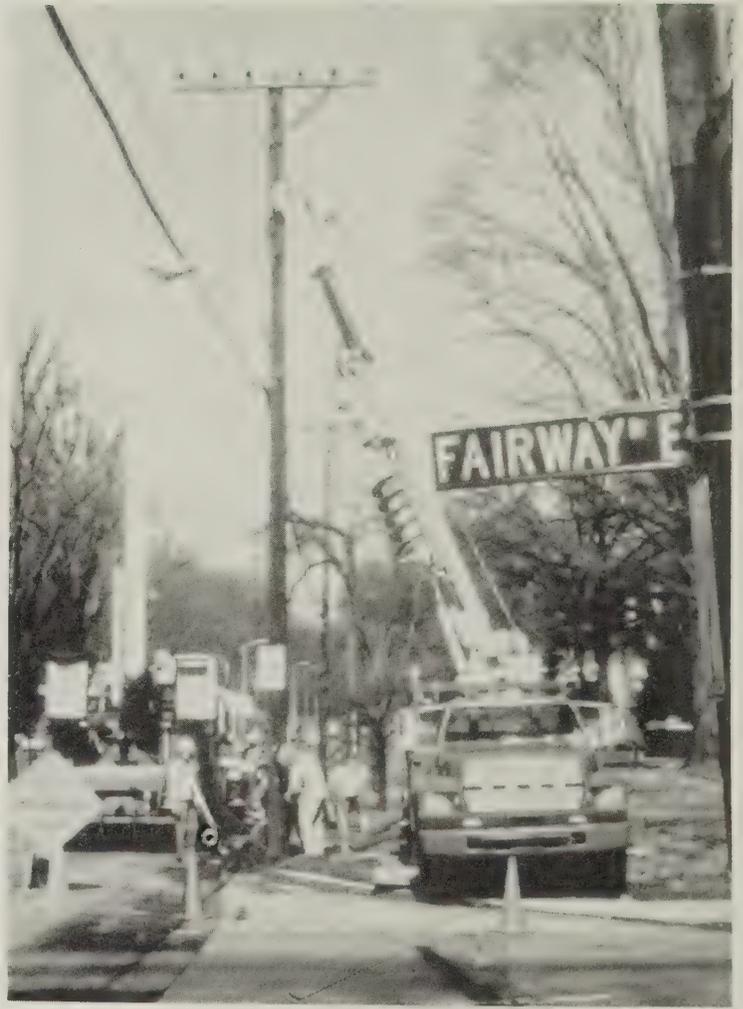
- As shown in figure 1, the upper part of the utility pole was stabilized by the boom arm of the digger derrick truck while work was performed on the bottom part of the pole. The crew then removed about 30 in (76.2 cm) of soil from around the pole's base. This gave the crew room to make a cut through the pole and ensured adequate space to put the lower half of the slip-base connection over the pole stub in the ground.

Figure 1.—Work zone site.

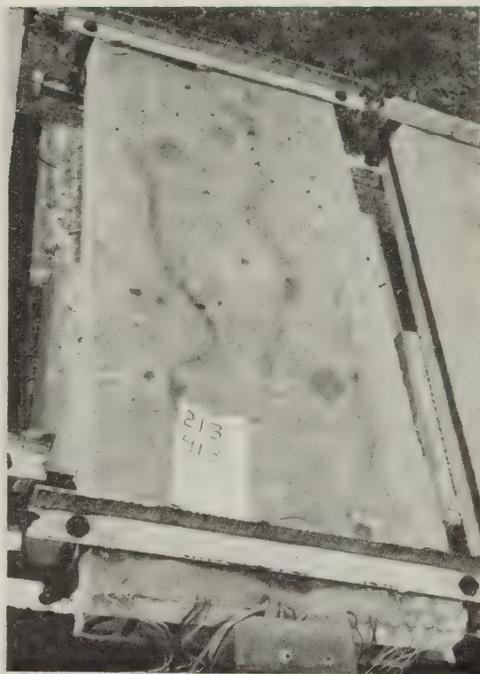
Figure 4.—Condition of selected slabs at 2429 days coupled (June 1987).

slab 213: No calcium nitrite: 7.9 lb Cl/yd^3

slab 219: 2.75% calcium nitrite: 8.4 lb Cl/yd^3

slab 215: No calcium nitrite: 23.3 lb Cl/yd^3

slab 227: 2.75% calcium nitrite: 20.2 lb Cl/yd^3

• The use of calcium nitrite was effective in reducing the rate of corrosion for black reinforcing steel embedded in poor-quality salt-contaminated concrete up to a Cl/NO_2 of 0.90. This conclusion is based on both periodic nondestructive data collected over 7 years and a visual survey of the slabs. Although slabs fabricated with a higher Cl/NO_2 (up to 1.11) indicated that there is a reduction in corrosion current flow by a factor of 10, the visual survey showed some cracking and rust spots on the concrete surface. Although slabs with a Cl/NO_2 from 1.3 to 1.8 showed an average reduction in the corrosion current by a factor of 2.7, they did have cracks and major rusting out of cracks and on the surrounding concrete surface. In addition, there were some hollow and spalled areas present on these slabs (224 to 228).
